Manhole Inspection Summary

Manhole # S43O__001MH

Insp Date: **5/19/09 11:56 AM**

Location Address: **1404 THAMES ST.**

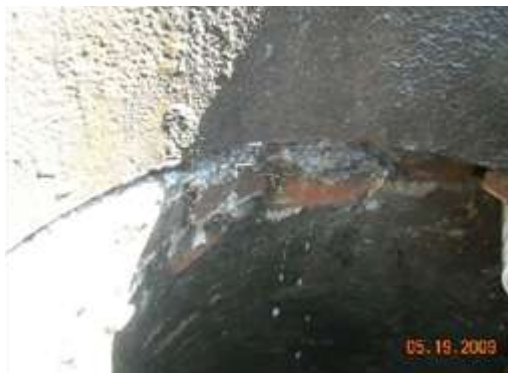
Defect 4

INFILTRATION DRIPPER

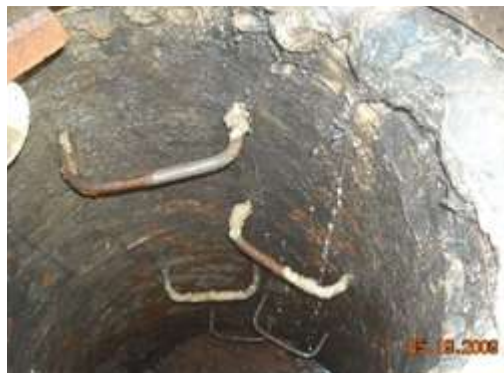
Defect 3

INFILTRATION RUNNER

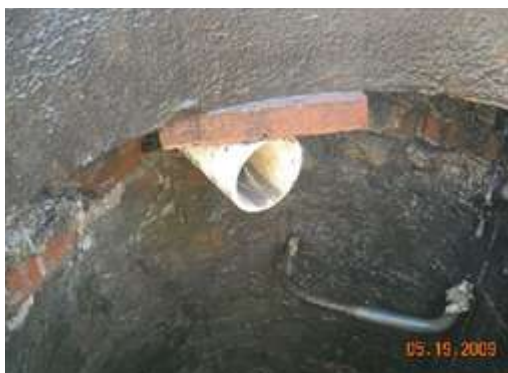
Defect 2

Condition: ☐ Sound ☒ **Cracked** ☐ Root Intrusion ☐ Loose Brick ☐ Deteriorated

Infiltration: ☐ None ☒ **Joint** ☐ Cracks ☐ Mortar ☐ Roots ☐ Wall

BREAK-IN POSSIBLE ILLICIT CONNECTION, cracked chimney

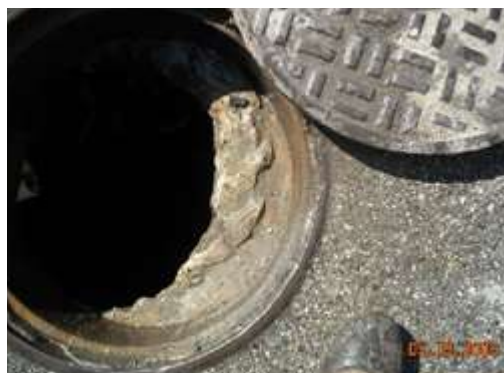
Defect 1

Frame Offset: **3** (in.) Condition: ☐ Sound ☐ Cracked ☒ **Leaks**

FRAME OFFSET

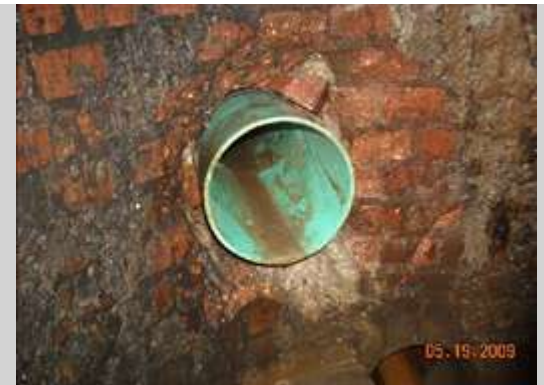
5 O'Clock Inflow

Pipe Height: **6** (in.) Rod and Bar (Angled)
Pipe Material: **PVC** ☐ Pipe Lined
Invert Depth: **7.49** (ft.) Flow Characteristics: **Slow**
Deposits: ☒ None ☐ Mud ☐ Sludge ☐ Debris ☐ Grease
Silt Depth: **0** (in.) Deposits Extent:
Infiltration: **None** Pipe Seal Cond: **Broken**

☒ Possible Illicit Connection

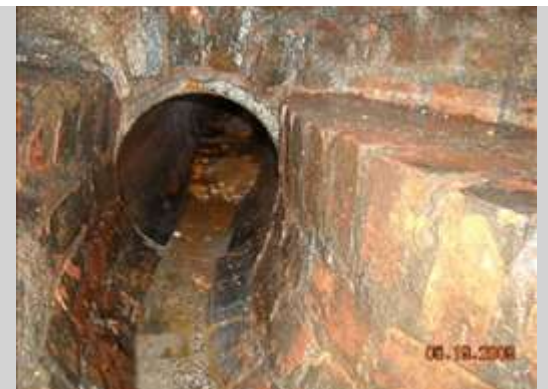
8 O'Clock Inflow

Infiltration: **Weeper**

Pipe Seal Cond: **Cracked**
